SCIENCE FOR GLASS PRODUCTION

STUDY OF DEFECTS IN QUARTZ GLASS WITH THE ACTION OF HIGH-VELOCITY MICROPARTICLES ON PORT-HOLES

V. F. Solinov¹Translated from *Steklo i Keramika*, No. 8, pp. 9–12, August, 2010.

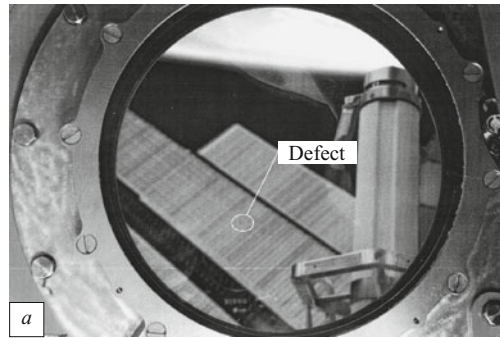
Traces of impacts of meteoritic microparticles on the 13-m port-hole were also found during the operation of the International Space Station (ISS) (Fig. 1). A 2.5 mm in diameter defect due to damage to the glass surface can be seen in a photograph of the port-hole. Is such a defect dangerous for further operation of the glass?

Fig. 1. Port-hole No. 13 on ISS: *a*) general view; *b*) 2.5 mm defect on quartz glass of the illuminator.

So, by analyzing a defect with diameter 2.5 mm in the No. 13 port-hole on ISS we can say that three fracture subzones are visible in this location, and this shows that the impact carried energy corresponding to a particle with diameter of the order of 0.17 mm and collision velocity $v = 6.8$ km/sec.

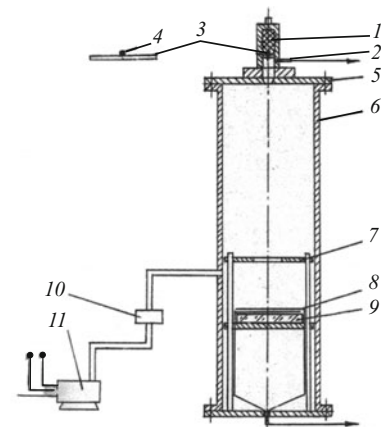
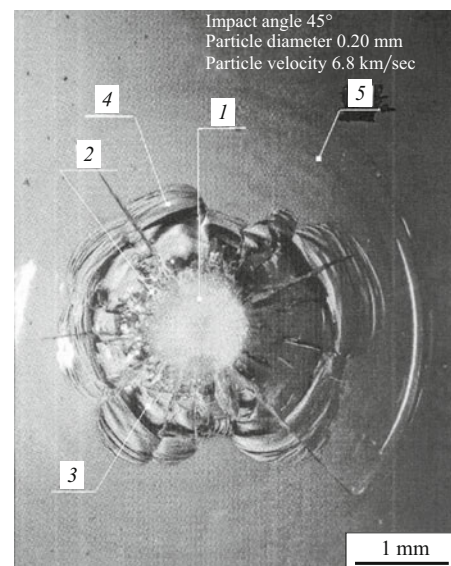
In the course of the tests it was found that for very strong impacts five subzones of different types of surface damage to the glass are observed (Fig. 3).

Fig. 3. Five subzones of damage in a defect: 1) zone of primary contact with a particle, ejection of fragments; 2) zone of fine cracking of the glass; 3) zone of internal convex-type chippings; 4) zone of internal concave-type chippings; 5) surface chipping.

It was found that the ends between chipping surfaces of the third and fourth subzones are locations of dangerous stress concentration.

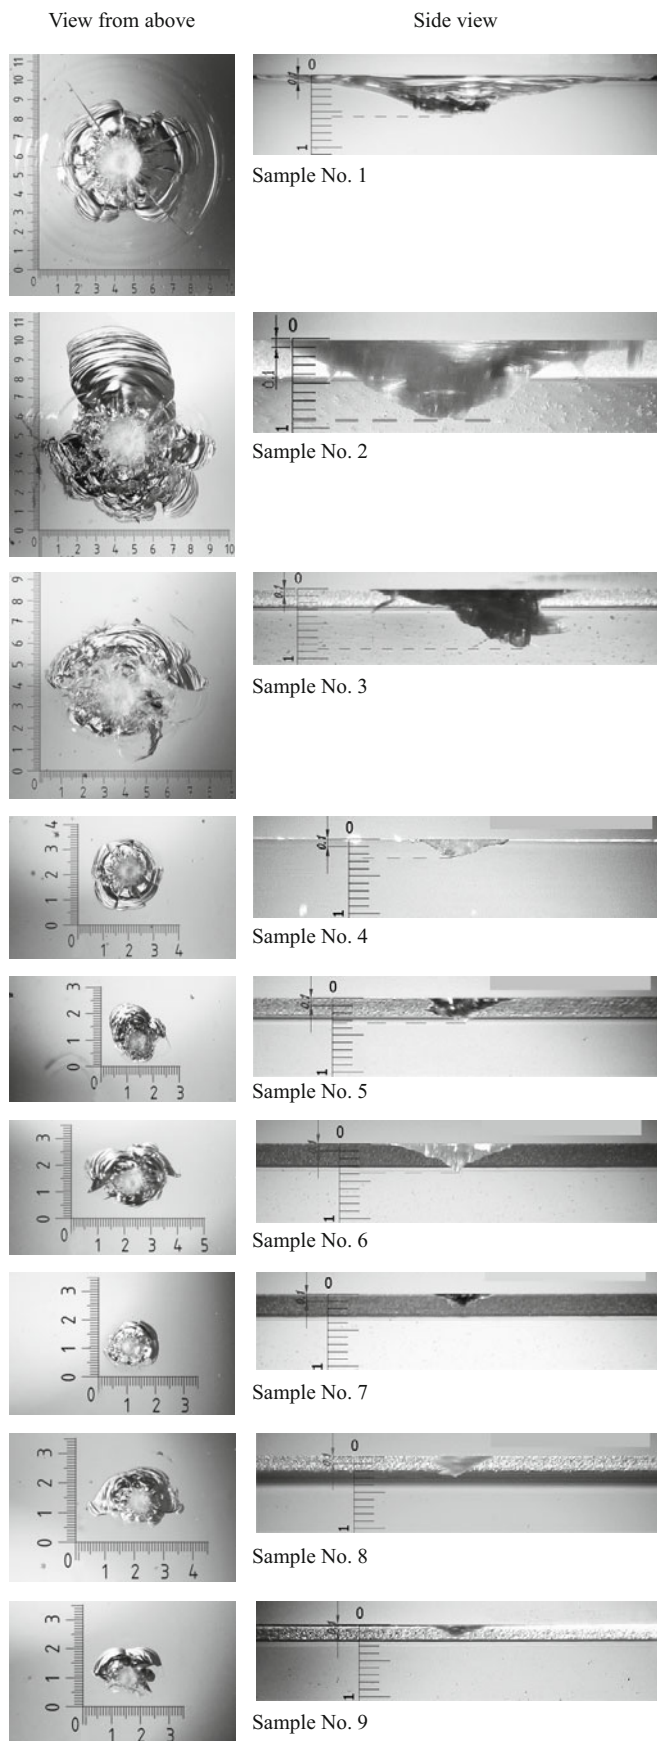
Zones of fracture of the samples in a collision (view from above and side) are shown in the photographs (Fig. 4). Analysis of the figures shows that as the impact energy increases, the morphology of the fracture zone increases and new defects appear (subzones).

Fig. 4. Zones of fracture of samples.

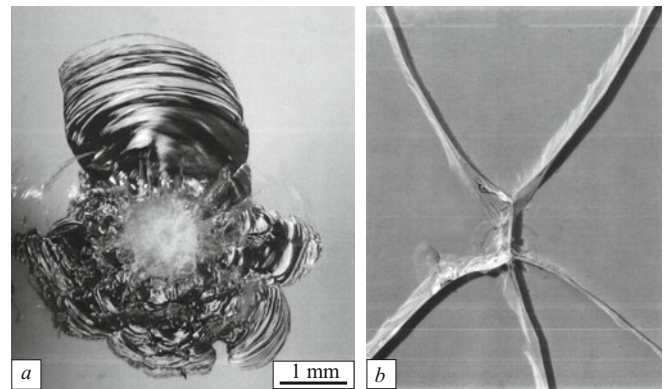
To determine the residual strength of the specimens it was proposed that the network of cracks be recorded after fracture and character of their development be studied. As a result it was found and is clearly seen that for practically all specimens when the center of the cracks formed coincides with the center of a defect (Fig. 8) the sources of the crack development are the ends of the edges of chip surfaces of the third and fourth subzones, which completely coincide with the network of cracks. Thus it has been established that in the case of impact by microparticles and observation in the fracture zone the third and fourth subzones we are dealing with stress concentrator that pose a danger for operation. For this reason, first and foremost, it is necessary to perform research work to evaluate the residual strength of glasses with defect in port-holes. Since third subzone has been found in a defect in the No. 13 port-hole on ISS, to ensure safe operation a stopper was delivered to the station and will be installed if the defect becomes larger. In addition, the search for criteria for evaluating the residual (permanent) strength of glass in the presence of a defect will continue.

**Fig. 8.** View of a defect on glass specimen No. 2, (a) and networks of cracks (b) after quartz glass was tested for fracture.
